AFATL-TR-66-72

Modified A/B45Y-1 Biological Spray Tank System (Phases I, II, and III)

by J. A. Kemp HAYES INTERNATIONAL CORPORATION

AUGUST 1966

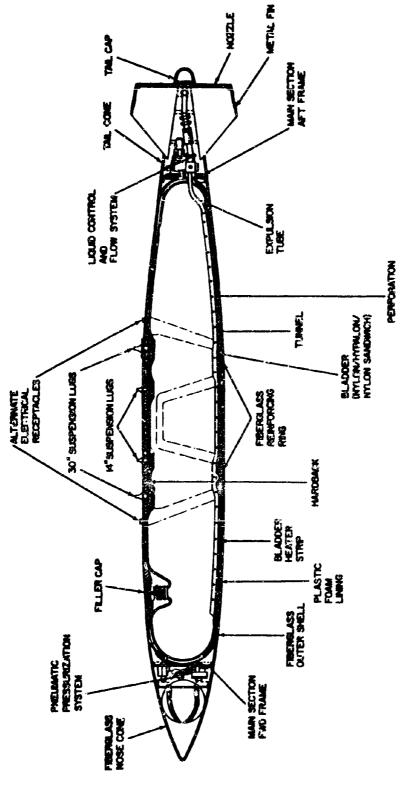
Figure 1 CUTAWAY VIEW, ORIGINAL TANK

The A/B45Y-1 Biological Spray Tank is an expendable type store which is capable of being attached to and ejected from the F100, F105, and F4C aircraft. In aerodynamic shape, size, and weight, the A/B45Y-1 tank resembles other stores presently carried and ejected from these aircraft. The tank is basically a laminated fiberglass shell in three sections, enclosing a flexible bladder liquid reservoir, a pressurization system, and a liquid control and spray system. Tank operation is electrically controlled from a remote panel. Upon application of the appropriate electrical signals from the panel, heaters may be turned on, pressurization is accomplished, and liquid dissemination initiated or stopped. The heaters prevent freezing of the liquid. The pressurization system introduces air into the cavity surrounding the liquid reservoir, and tends to collapse the bladder. The liquid system controls escape of liquid under pressure from the bladder to the dissemination nozzles. Liquid flow is sensed by a transmitter which returns an electrical signal to the control head and causes a flow indicator light to illuminate. Suspension lugs are provided for attaching the unit to the aircraft. Four fins stabilize the tank aerodynamically and support the spray nozzles. An external electrical receptacle links the tank to the control head and to the aircraft electrical heating equipment. Refer to Figure 1.

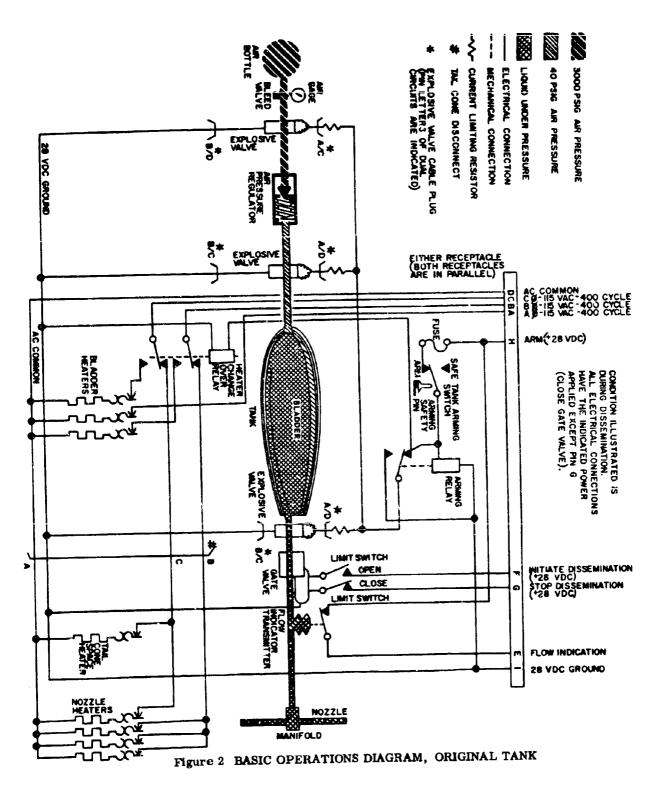
A review of the Technical Orders for the subject aircraft was carried out in order to ascertain details of the existing aircraft wiring and switching available at the external store locations for operating the spray tank. Schematic diagrams of these circuits are given in the following figures:

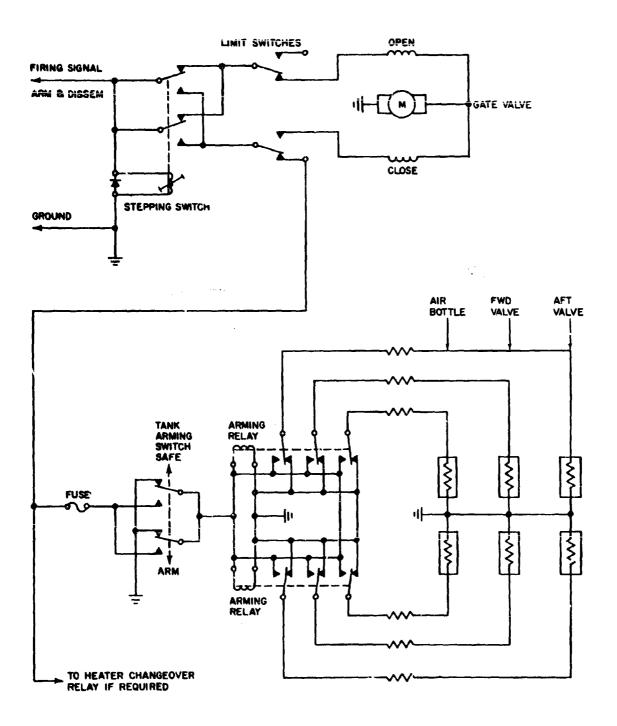
Figure 8 TANK CONTROL CIRCUIT - MULTIWIRE

> <u>Multiwire Circuit</u> - In the multiwire circuit, the gate value and arming circuits are separated (see Figure 8). The stepping switch is homed to the "CLOSED" gate value position at checkout and the gate value is closed. This is achieved by the test set. Operation of the bomb arming switch to the nose and tail position arms the spray tank. The first pulse on the pickle button steps the stepping switch to the "OPEN" gate value position. This opens the gate value and initiates dissemination. The second pulse from the pickle button steps the stepping switch to the "CLOSED" gate value position. This closes the gate value and stops dissemination. Successive pulses repeat this on-off dissemination control.

Approval for the additional wiring in the F100 and F105 pylons was received shortly after these two circuits had been evolved. Initially, the obvious choice was to use the multiwire circuit (see Figure 8), however, as the stepping switch had originally been selected because sequential operation for arming and push on - push off control had been dictated by the single wire circuit, it was decided to review the control system. Problem areas associated with the stepping switch and sequential operation which prompted this review were:

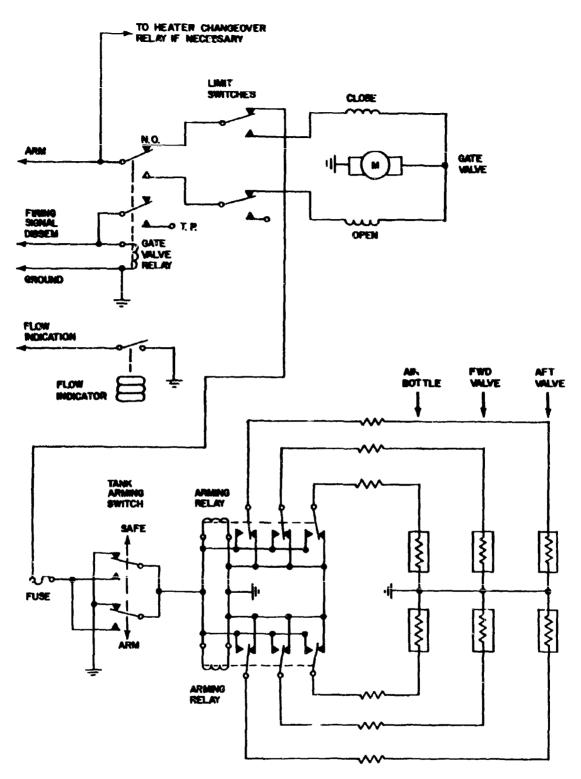
The final control circuit (see Figure 9) uses a relay to steer power to the "OPEN" or "CLOSED" windings of the gate valve motor. The normally open contacts of the relay are connected to the "CLOSED" side of the gate valve motor. Power to drive the gate valve motor is taken from the nose-tail arming circuit which is also used to arm the tank. The gate valve relay coil is connected to the pickle button. Depression of the pickle button energizes the relay coil closing the relay contacts which steers arming power to open the gate valve motor. Release of the pickle button de-energizes the relay coil which steers power to close the gate valve. This gives push on, release off dissemination control.

The nose-tail arming switch is energized through a circuit breaker connected in series with this switch on the F100 and F105 aircraft and on the F4C aircraft, the circuit is also directed through the master arming switch located in series between the circuit breaker and arming switch. This gives a minimum of two stage isolation on all aircraft.

с. . The pickle button is connected in series with, and energized through, a circuit breaker and the master arming relay on all three aircraft resulting in a three stage isolation of the pickle button.

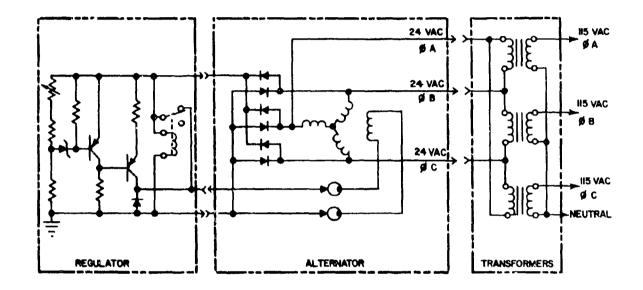
Figure 15 115 VAC THREE PHASE POWER SUPPLY

3. As the heaters are individually thermostatically controlled, the total load would vary randomly and this could be applied assymptrically between phases creating a phase unbalance condition. The design of the regulator (see Figure 15) was such that the sensed output voltage was the average of the rectified outputs from the three individual phases. Consequently, a no load condition on one or more phases would produce a larger sensed voltage resulting in a reduced field current being supplied by the regulator to the field exciter winding resulting in a reduced field current being supplied by the regulator to the field exciter winding resulting in a reduction of the output voltage and power delivered by the loaded phase or phases. As the turbine was capable of providing at least 900 watts of power, which exceeded the maximum demand of 810 watts required by the preferred all-heater-on-all-the-time condition, it was decided to eliminate the transformers because of their possible 85% efficiency and to rewind the alternator to provide a 115 VAC single phase output. Single phase was chosen to eliminate the three phase unbalance problem. Consequently, the self-contained power unit circuitry was redesigned as shown in Figure 16.

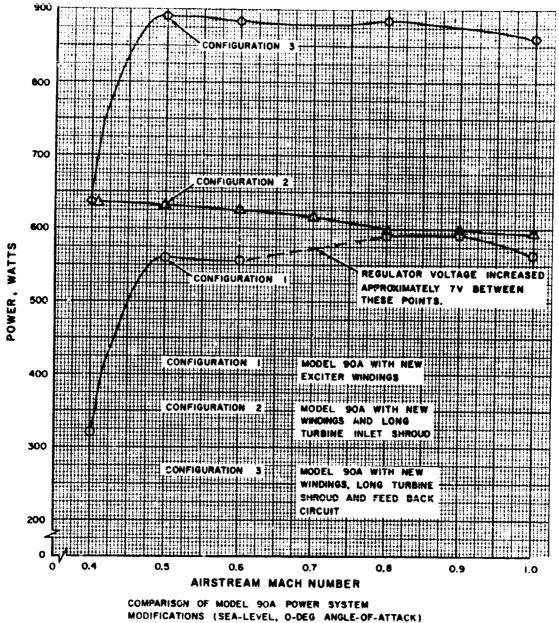
Figure 17 COMPARISON OF MODEL 90A POWER SYSTEM

The curves presented in Figures 17, 18, and 19, present a summary of the significant results obtained during the wind tunnel testing. Data were obtained at simulated flight conditions within a MACH number range of 0.4 to 1.29 at altitudes ranging from sea level to 40,000 feet. The tests were conducted during the period January 13 through February 5 1965 in propulsion engine test cell (T-1) of the rocket test facility.

The initial test of the program was made at pressure altitudes from 10,000 feet to 40,000 feet and MACH numbers from 0.4 to 1.0. The alternator output was found to be much lower than the desired 900 watts, hence modifications consisting of a new alternator field exciter winding, addition of an output to field voltage feedback circuit and a longer turbine inlet shroud were designed and incorporated by Hayes personnel to improve system performance. Comparative data showing the methods with each

modification at sea level conditions, 0 degrees angle of attack are shown in Figure 17. The modifications improved performance significantly and the remainder of the test program was conducted with the configuration 3 power unit (new exciter field winding, addition of feedback and longer turbine shroud).

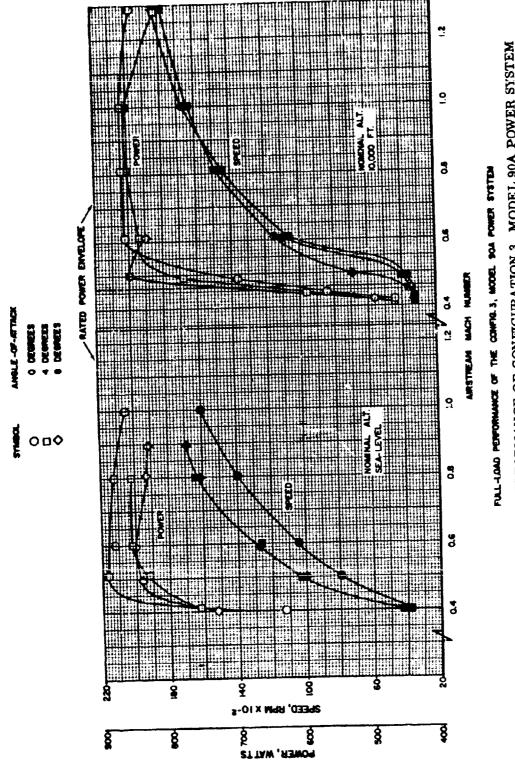
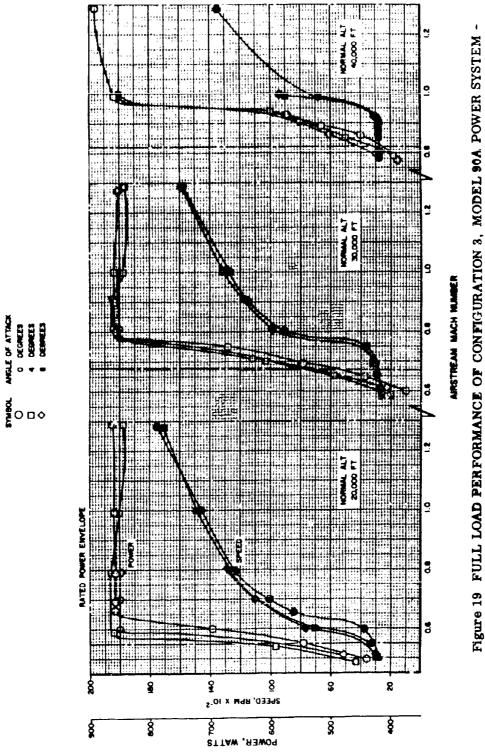
The data obtained with the configuration 3 system at 0, 4, and 8 degree angle of attack at four pressure altitudes are shown in Figures 18 and 19. Performance data consisting of alternator output power and speed are shown for each test condition. Except for sea level 0 degree angle of attack, all data were obtained with the alternator loaded with nine 125 ohm resistors plus one 100 watt bulb. When the sea level 0 degree angle of attack data were obtained, a faulty voltmeter imposed an approximate 45 watt additional load on the alternator. This probably accounted for the high power output although the additional 45 watts should not drop the alternator speed as much as indicated. The fact that these data were obtained with a slightly different turbine wheel than the remainder of the data were obtained with, could also contribute to the speed difference.

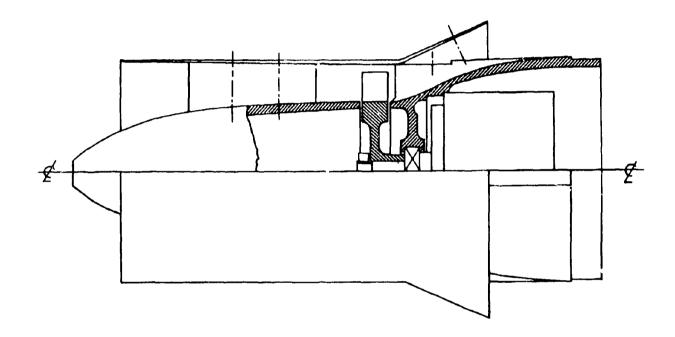
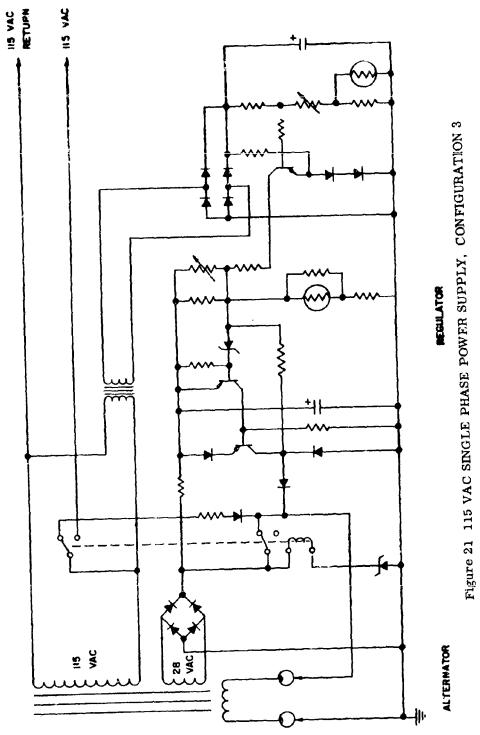
The alternator configuration showing the extended shroud added during the wind tunnel test program and the revised regulator circuits are shown in Figures 20 and 21.

This configuration and circuit was adopted for inclusion on the remaining Phase II hardware, existing units being retrofitted to incorporate the changes.

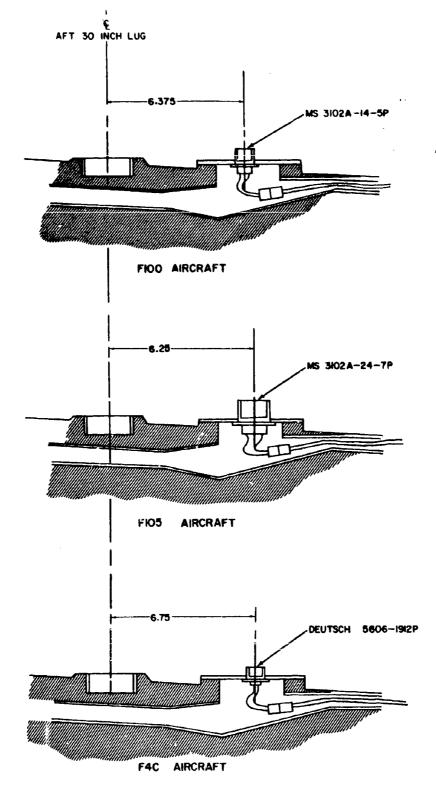
Figure 22 MODIFIED AFT CONNECTOR MOUNT

For mechanically locating the interface connector, a well was cut in the tank by elongating the existing hole in the wiring tunnel and a boss bonded to the outer skin to provide a flat mounting surface with eight tapped mounting holes (see Figure 22). For each aircraft type, an adapter plate was designed that would mount to this surface with provision to assemble the appropriate interface connector at the correct station location (see Figure 23). The adapter plate and adapter cable are furnished as an integral assembly and suitably identified. For shipping, the tank is fitted with a cover plate on the boss, which is removed and replaced by the appropriate electrical interface adapter assembly prior to installing the tank on the aircraft.

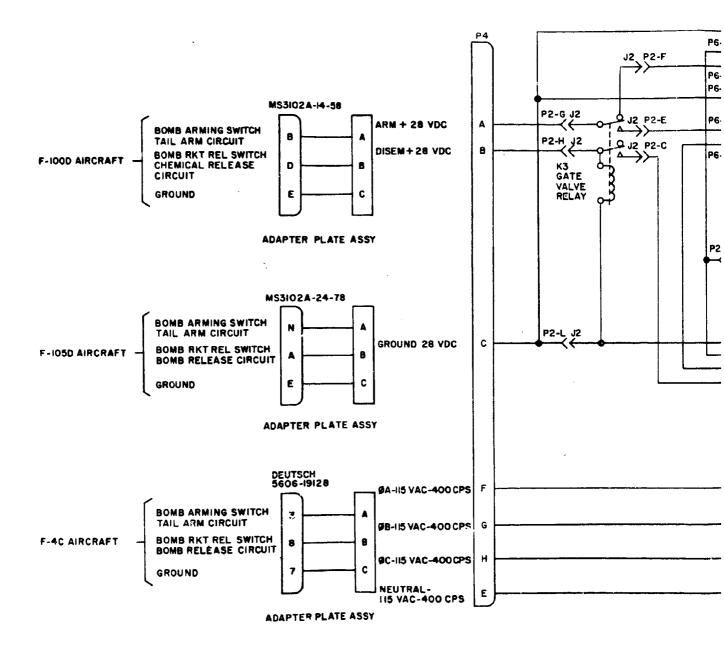
Figure 29 SCHEMATIC A/B45Y-1 SPRAY TANK MODIFIED UNDER PHASE III

APPLICABLE TO THE FOLLOWING TANKS ONLY: SERIAL NUMBERS

NOZZLE HEATERS 75 W EACH
